TECHNICAL REPORT ARCCB-TR-02016

**CHARACTERIZATION OF EXPLOSIVELY BONDED AND
FIRED TANTALUM LINERS APPLIED TO 25-MM GUN TUBES**

NOVEMBER 2002

**US ARMY ARMAMENT RESEARCH,
DEVELOPMENT AND ENGINEERING CENTER**
Close Combat Armaments Center
Benét Laboratories
Watervliet, NY 12189-4000

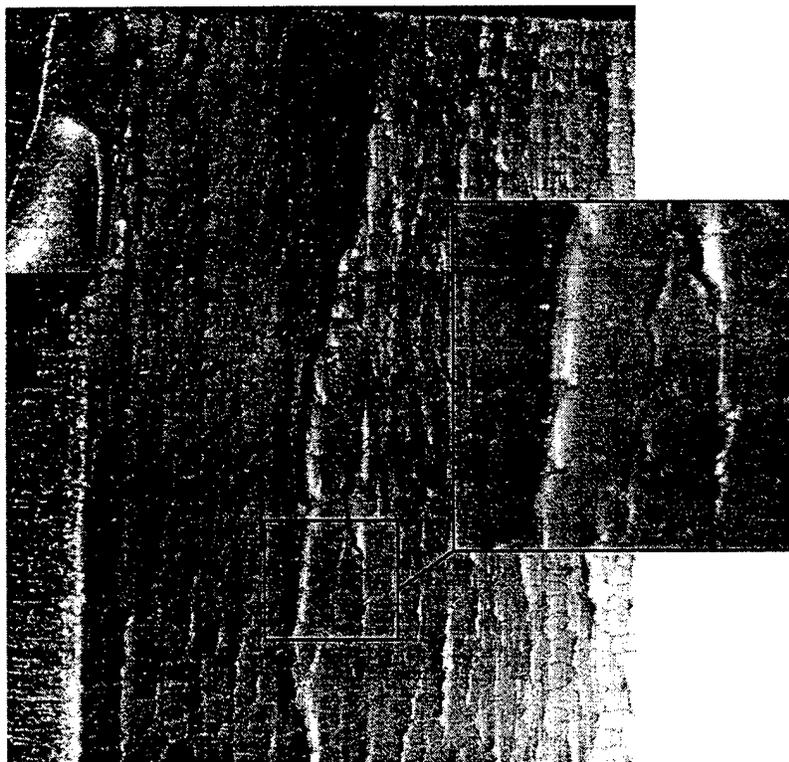
The most predominant erosion patterns of Tube B were readily distinguishable with visual and stereomicroscopic examination. Heavy heat-checking and thermomechanical/thermochemical damage of the coating is evident at the 6- to 10-inch location, along with the development of deep erosion troughs that extend well into the steel (Figures 3 and 4).

Figure 3. Severe heat-checking and gas erosion exhibited at the 6.5-inch location of Tube B.

Following sufficient uniform erosion of the liner, the propensity for blow-by of the hot gases due to poor obturation increases. This stage of the erosion process is illustrated by the gas-wash grooves shown in Figures 3 and 4. The inset in Figure 3 is an example of a gas-wash groove following along the heat-check cracking caused by hydrogen embrittlement. The heat-check cracks act as a conduit for the axially oriented gas-wash grooves, thus increasing the speed of this erosion process. Figure 44 is a cross-section taken at the 10-inch from RFT location, and illustrates the severity and dominance of the hot gas erosion at this stage. The final stage of the erosion process exhibited in this tube is in full erosion of the liner at an axially oriented groove and subsequent rapid erosion in the steel as is illustrated in Figure 45.

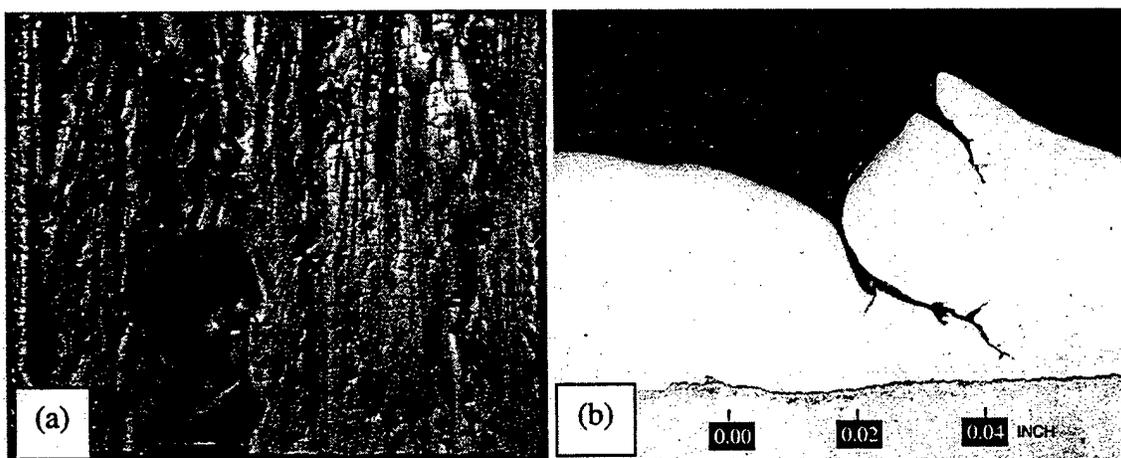
Figure 4. (a) Severe heat-checking and gas erosion exhibited at 8 inches from the rear face of the tube (RFT), and (b) cross-section of Tube B at 50X.

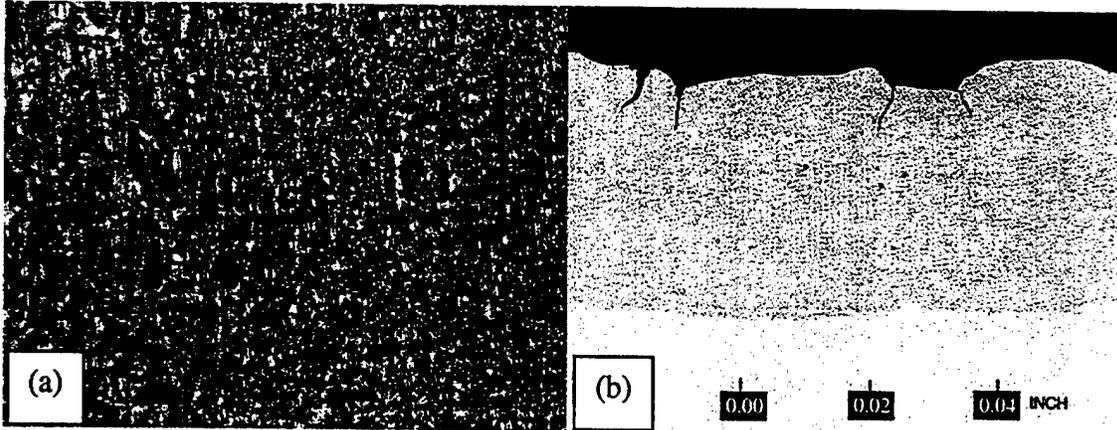
Heat-checking was also evident at the 12- to 14-inch location, along with a general surface roughening as shown in Figure 5a. This roughening is due to the cracking followed by some plastic flow and erosion in this area. This was confirmed by metallographic observations made at this location (Figure 5b).

Figure 5. (a) Surface roughening exhibited at 12 to 14 inches from RFT, and (b) cross-section of Tube B at 50X.

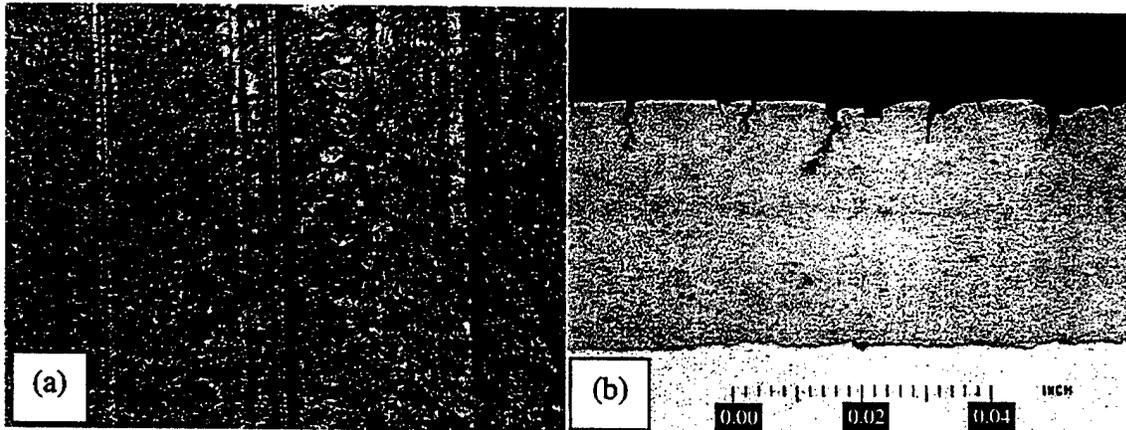
Acute surface roughening was seen in the 18- to 20-inch location (Figure 6). Upon metallographic examination, it was found that cracking also contributed to roughness at this location. Here, the cracks are more finely spaced and shallower than in the locations closer to the breech.

Figure 6. (a) General surface roughening seen at 18 to 20 inches from RFT, and (b) longitudinal cross-section of Tube B at 50X.

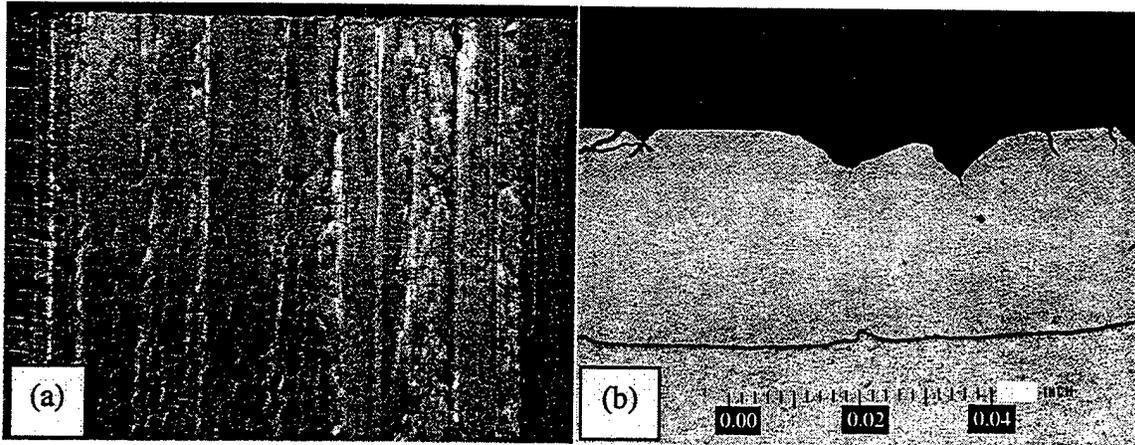
The most dominant feature of the Tube C specimens was severe erosion of the lands up to about 16 inches from RFT (Figures 7 and 8), including near complete obliteration nearest the origin-of-rifling (4- to 8-inch location). Also, seen in the liner of the 4- to 8-inch section were heavy heat-checking and stress patterns similar to those observed in Tube B.

Figure 7. (a) Heat-checking and land erosion at 4 to 8 inches from RFT, and (b) cross-section of Tube C at 50X.

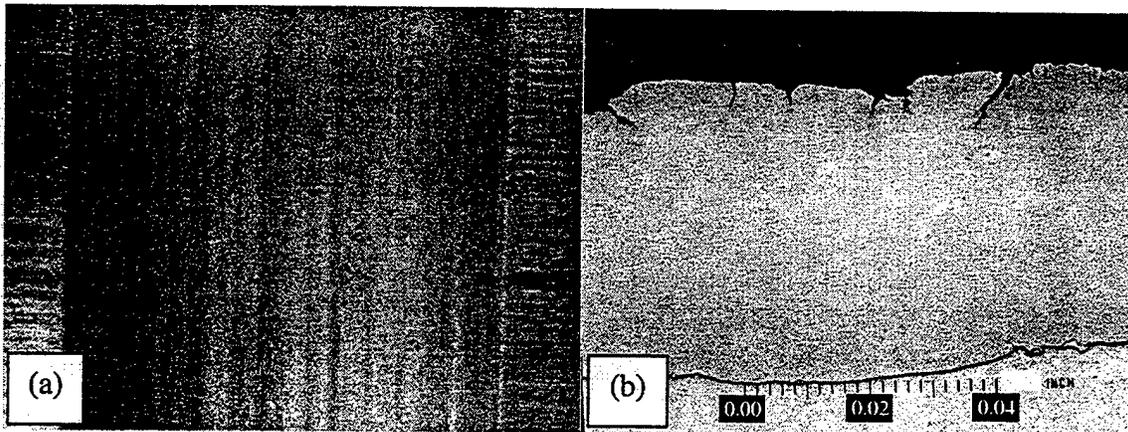
Figure 8. (a) Surface roughening and land erosion at 14 to 16 inches from RFT, and (b) cross-section of Tube C at 50X.

Besides the heavy wear and erosion seen in the main bore in the 14- to 16-inch location, there occurred a general roughening similar to that of Tube B. As with Tube B, this roughening seemed to occur due to cracking of the coating at the surface, followed by deformation and preferential erosion within the cracks (Figure 8b).

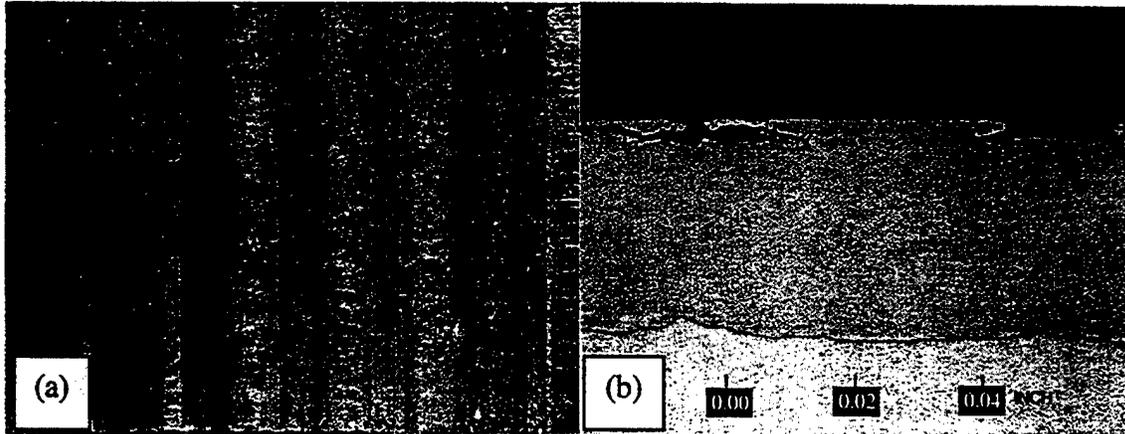
A general roughening of the surface in the 28- to 30-inch location was also observed (Figure 9a). The roughening observed here is due to both cracking and loss of the coating at what appears to be an interfacial phase formed from the dual explosive bonding process (Figure 9b), which will be discussed in a later section.

Figure 9. (a) Wear and surface roughening at 28 to 30 inches from RFT, and (b) longitudinal cross-section of Tube C at 50X.

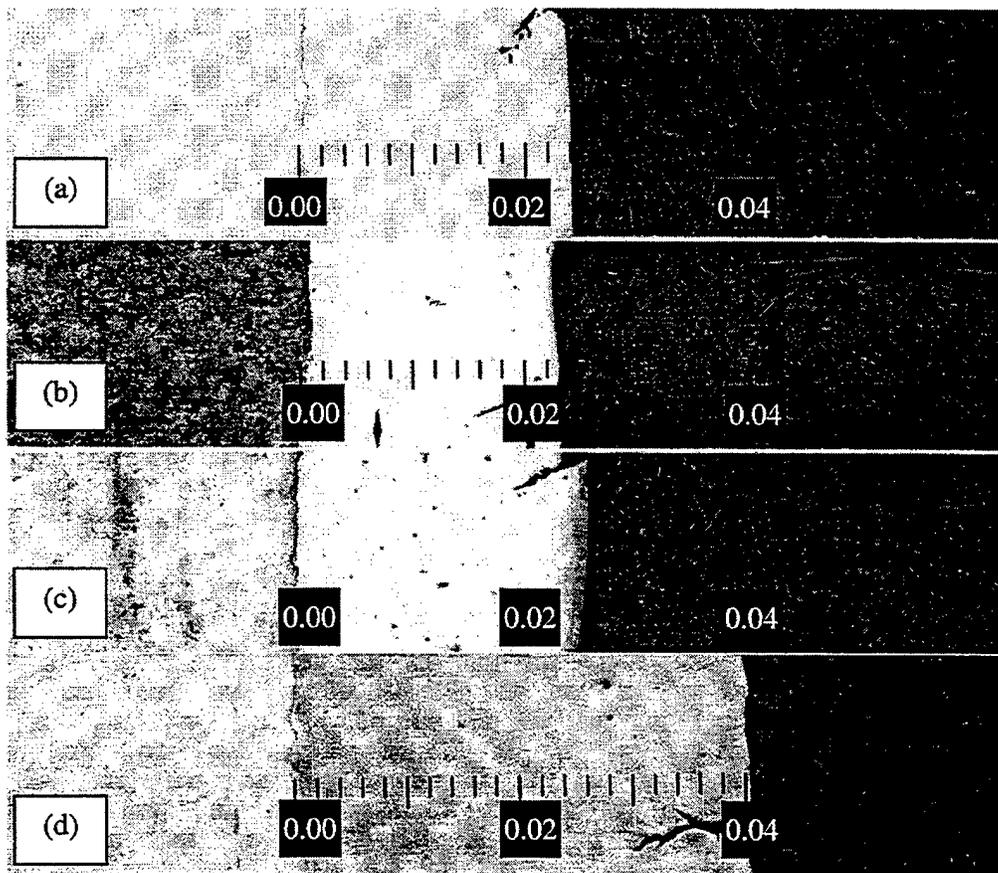
For Tube B, liner thickness measurements were made at 6.5, 10, 14, 20, and 40 inches from RFT in the fired smoothbore specimen. Assuming an initial liner thickness of ~ 0.040 -inch, the final thickness measurements of the liner agree well with the bore gauging measurements taken during testing at Aberdeen Proving Ground (ref 1). Figure 11 illustrates several thickness measurements. See Table 1 for complete coating thickness measurements.

Figure 11. Coating thicknesses of Tube B at (a) 6.5, (b) 10, (c) 14, and (d) 20 inches from RFT.

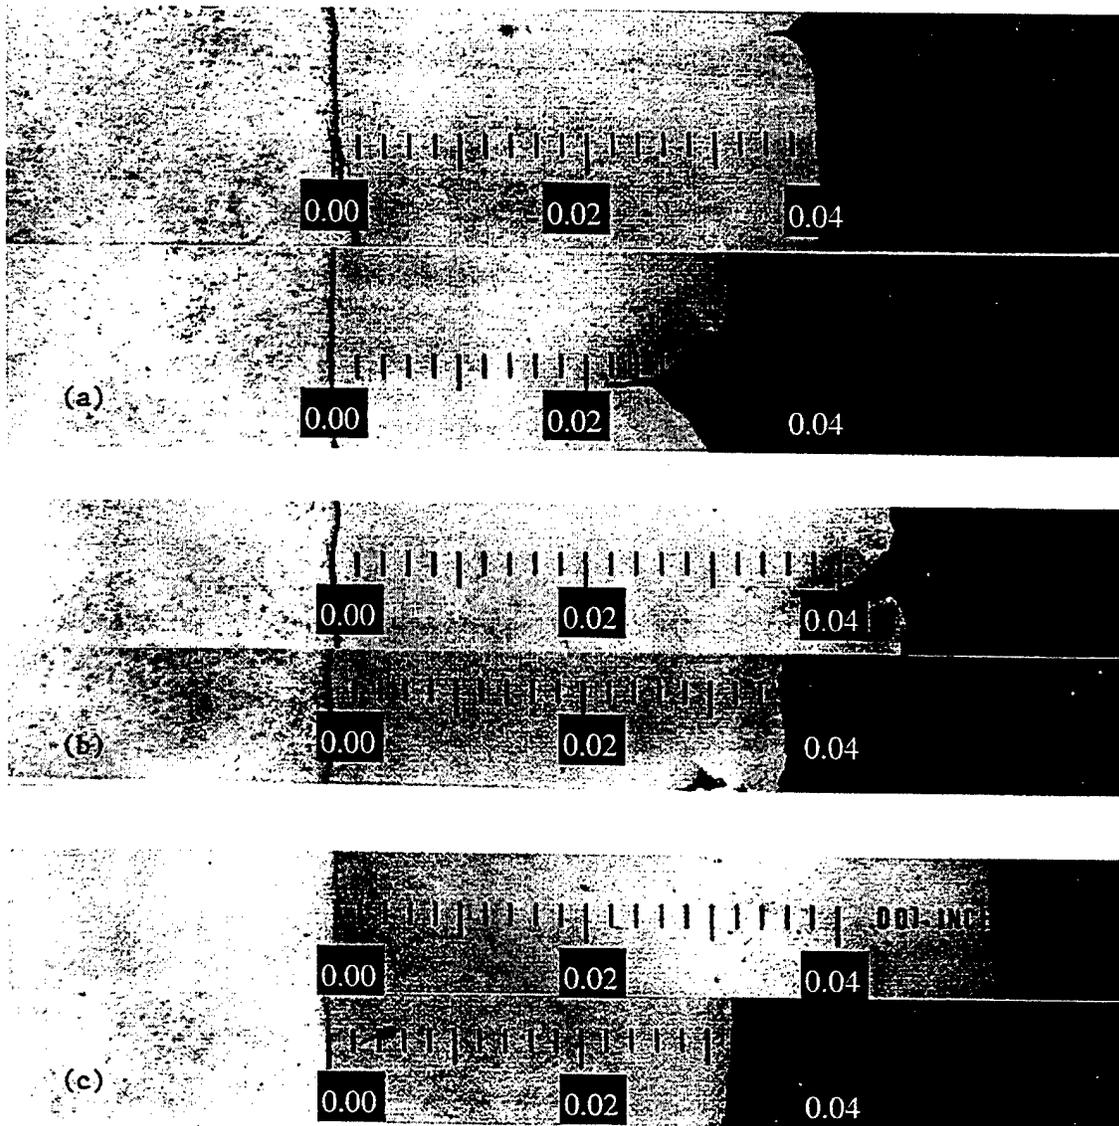
For Tube C, liner thickness measurements were made at 8, 14, 30 and 40 inches from RFT in the fired, no-twist, rifled specimen. At the 8-inch location, the lands were difficult to distinguish from the grooves in the stereomicroscope, as near complete obliteration of the lands had occurred in this location. The liner thickness down bore was much greater than the nominally reported 0.042- and 0.021-inch for land and groove, respectively; but if in fact the liner thickness was indeed 0.060-inch on the lands and 0.037-inch in the grooves, the erosion data compiled at ATC would better correlate to the thickness readings. Figure 12 illustrates several thickness measurements. See Table 1 for complete coating thickness measurements.

Figure 12. Coating thicknesses of Tube C at (a) 8, (b) 16, and (c) 30 inches from RFT.

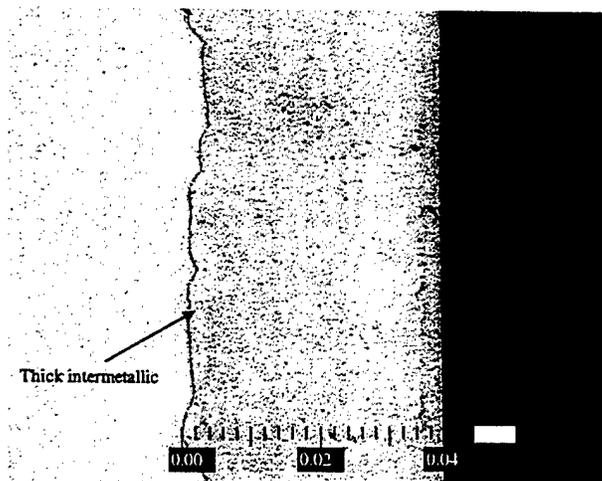
The microstructure of the bulk coating of Tube C was dense and defect-free. Again, an intermetallic was present along much of the interface of this specimen exhibiting similar properties as those in Tubes A and B. From metallographic examination, it appears the explosive bonding process was overly energetic at the 30-inch location. Here, a very thick intermetallic (~3 to 5 mils) was present as is illustrated in Figures 17 and 18. Along with this, a shallow heat-affected zone is present in the steel at the interface of the intermetallic.

Figure 17. Thick intermetallic of Tube C at 30 inches from RFT at 50X.

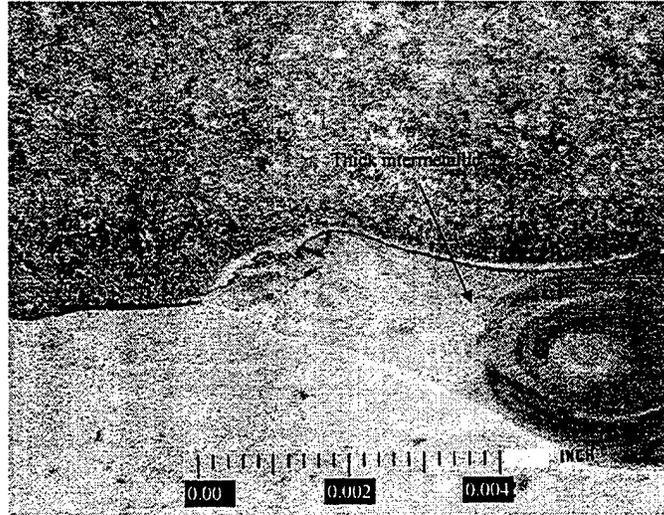
Figure 18. Thick intermetallic and heat-affected zone of Tube C at 30 inches from RFT at 500X.

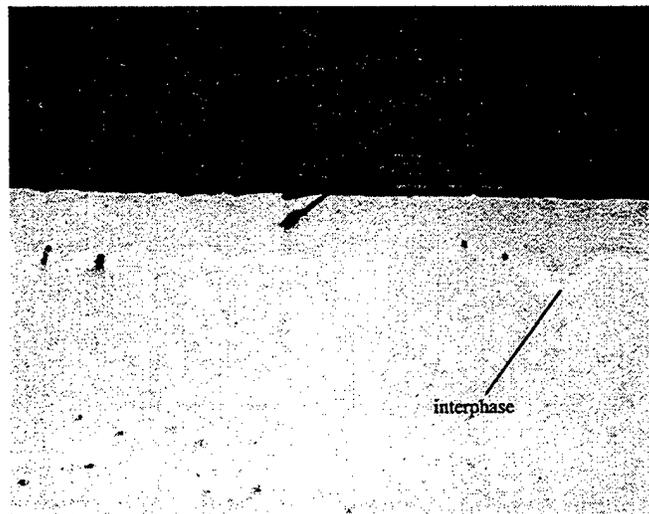
Besides the intermetallic at the interface, there also appeared to be an intermetallic in the liner itself (Figure 19). This is believed to be due to the dual explosive bonding process in the rifled tube in which two liners were explosively bonded successively, and then the rifling broached out. The appearance of this intermetallic is strange in that it should be a pure tantalum/tantalum bond at this interface. This intermetallic is similarly brittle to the iron/tantalum intermetallic and prone to cracking (Figure 20). The hardness of this intermetallic is \sim HK₅₀ 800. The composition of this intermetallic was examined using SEM and EDS as discussed below.

Figure 19. Unidentified phase in rifled liner of Tube C at 150X.

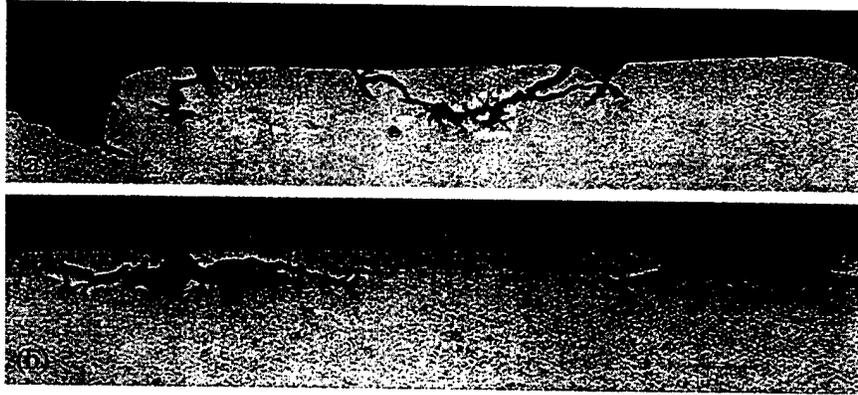
Figure 20. Interphase degradation of Tube C at (a) 8-inch location, and (b) 30-inch location.

The overall erosion characteristics and cracking of Tube C are similar to that of Tube B with the exception of failure of the liner at the interphase tantalum formed by the dual-explosive bonding process. The presence of this phase at an interface near the surface of the liner may lead to extensive premature liner spallation of the lands during firing.

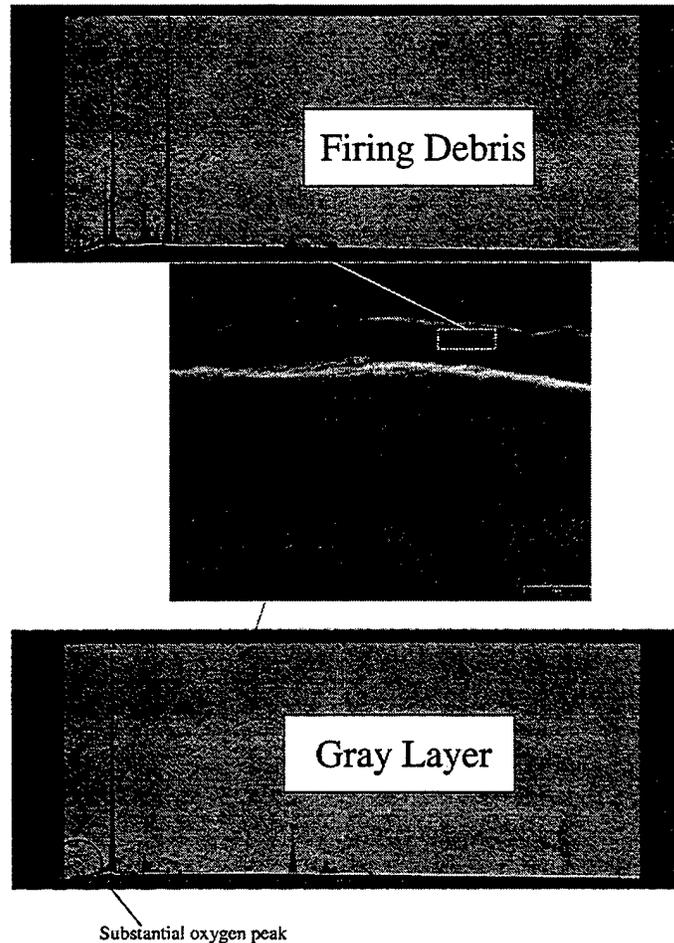
In addition, Figure 23 illustrates a gray layer observed on the surface. Based on EDS results, this layer appears to be a tantalum oxide (Figure 24). This is further supported by the WDS results described next.

Figure 24. Results of EDS on surface layer of the Tube C tantalum liner. The substantial oxygen peak observed indicates the presence of a surface oxide.

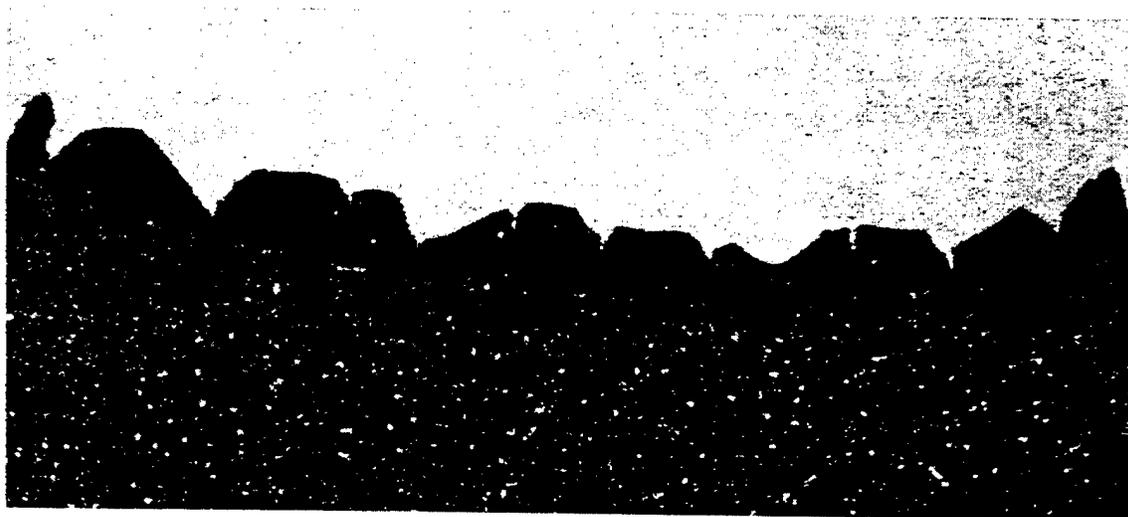
Figure 44. Stereomicrograph of severe gas erosion in Tube B at 10 inches from RFT at 10X.

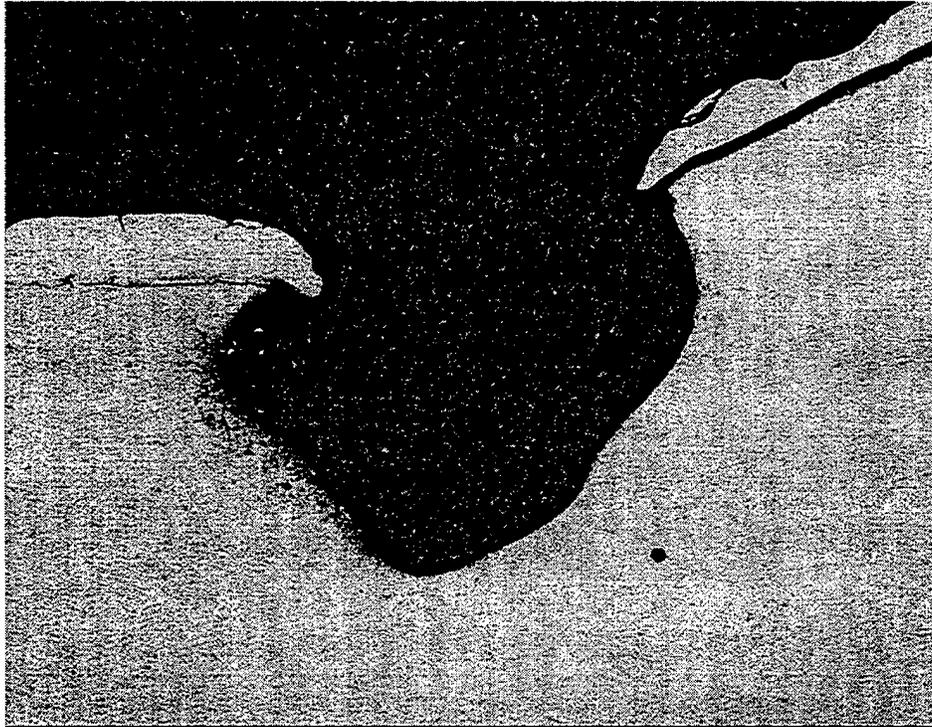
Figure 45. Severe erosion of underlying steel in Tube B at 8 inches from RFT at 15X.
